TAMIL NADU

K.1. A Case Study from Mannchanallur, Tiruchirapalli

The Integrated Wasteland Development Programme Project – II being implemented in Mannchanallur Block, Tiruchirapalli District. The number of Watersheds sanctioned is 11 with Project Area of 5650 Ha. In the Palaiyur Watershed under IWDP – II that lies in Palaiyur Panchayat, the number of land holdings by the Marginal & Small Farmers is 242 out of a total of 275 – 88 % and that of SC / ST Holdings is 47 – 17 %. The number of BPL family is 405 out of 707 – 57 %. The Treatable area in the watershed is 480 Ha and the area so far treated is 409 Ha.

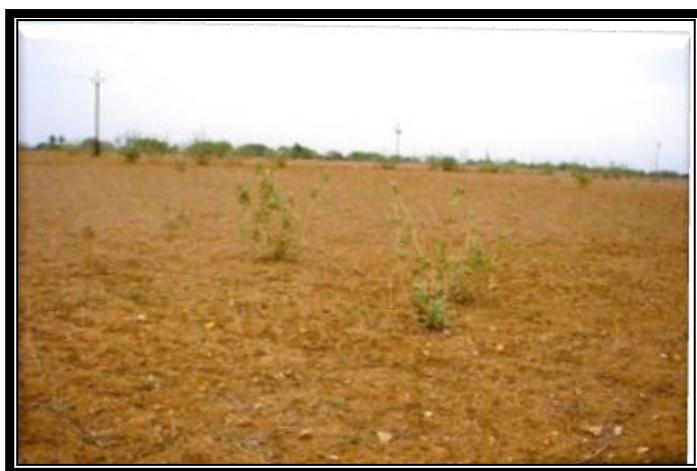
Photo 1: A view of the plot before treatment

The land was left barren for nearly 4 years even though it is cultivable. The topography of the land is sloping and irrigation is not possible for cultivation of crops. The Small farmer was unable to take up the Land Development on his own and was in need of motivation as well as assistance.

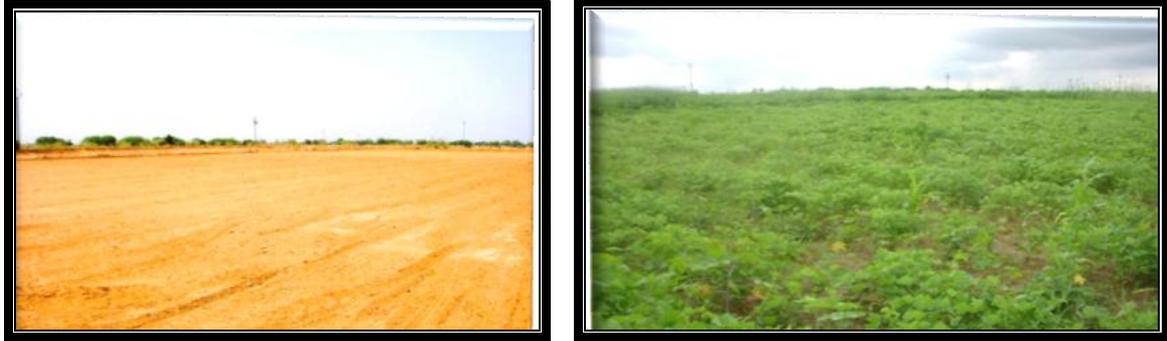
Photo 2 & 3: Views of the plot during the land development work and in the cropped stage

The cultivable fallow land is 1.40 Ha. and 1.00 Ha. land was taken up for treatment. Sorghum was cultivated in 0.50 Ha. and Field beans & Castor was cultivated in 0.50 Ha. under irrigated condition. The additional income was Rs.15,000/- in the same season in which the land was developed. As the work was carried out by the beneficiary himself, the maintenance & after care is taken care of and sustainability is ensured.

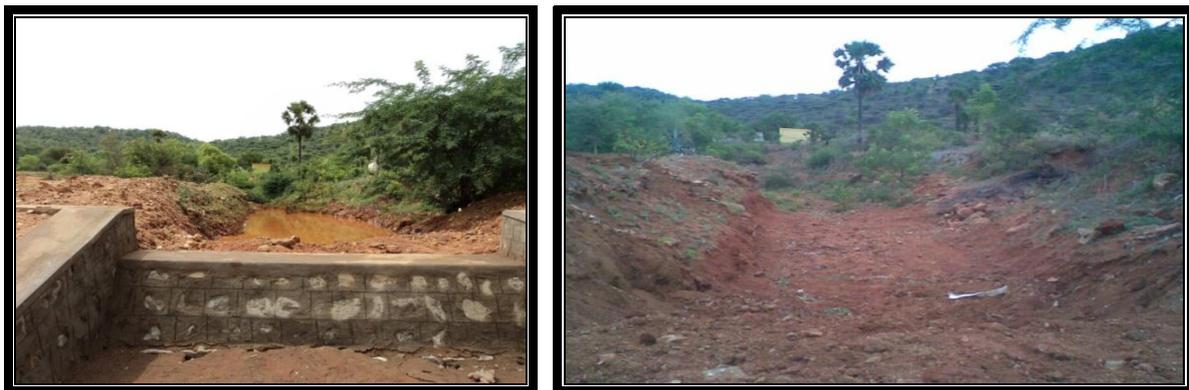
Photo 1 & 2: Before and after construction of check dam under the project

Rainwater was harvested immediately after construction to its full capacity. The Groundwater level is increased in the nearby well by 2 m. The water is now available for an additional period of 30 days. This year in the first season, the farmer has cultivated Groundnut and in the next season he preferred Sorghum as the water available now is more.

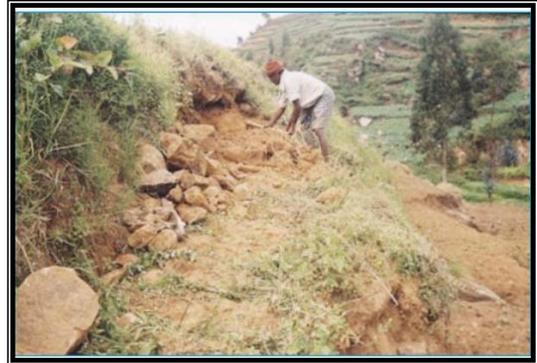
The watershed in the kodaikanal block are situated in the steep sloppy western Ghat hills. The slope of the land is more than 31 % and the lands in this sloppy portion starve for conservation from all types of erosion and loss in the top fertile soil. It makes the roots exposed and even hills the plant and destroys agriculture.

Photo 1: Before project

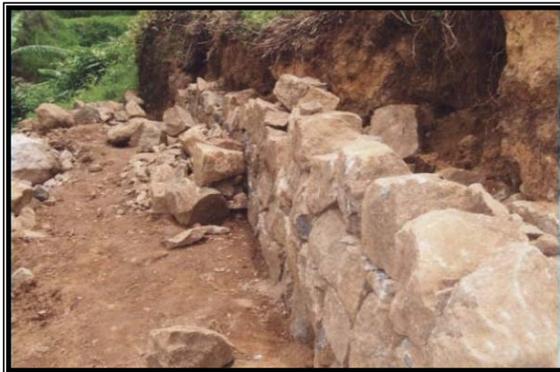
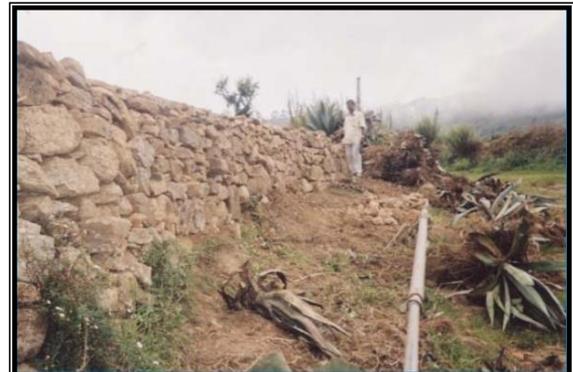
It was planned to construct stone bunding in the possible contours of the agricultural field with the dimension of 0.60 m width and height ranging from 0.60 m to 1.20 m. It was constructed with the available stone in the respective field itself. The movement of the top soil was collected within the field and the soil around the root zone was unearthed.

Photo 2 & 3: Stone Bunding, Mannavur Watershed

The annals reveal that the run off was arrested efficiently in the sloppy lands of the watersheds. It stabilizes the agriculture in approximately 65 ha per watershed affected seriously from the erosion. The 4 watersheds which have black cotton soil as its top soil the erosion was controlled remarkably. The soil retained soil moisture, humus content, applied fertilizers and microbial activity.

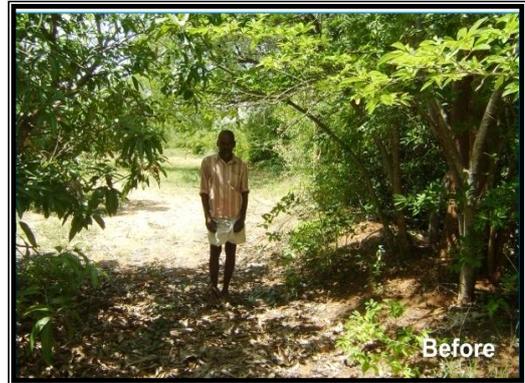
The watersheds are situated in the dry belts of Athoor and Natham blocks of Dindigul District. It receives to an average rainfall 755 mm/year. the distribution of rainfall is also irregular. It has a hilly range as its ridge. There are 21 backward class families and 3 schedule caste families owning 67 ha of lands in Natham and 11 BC families in Athoor owning 19 ha the lands were facing a great threat of erosion since the slope of the land lies between 7 to 13%.

Photo 1: Before project

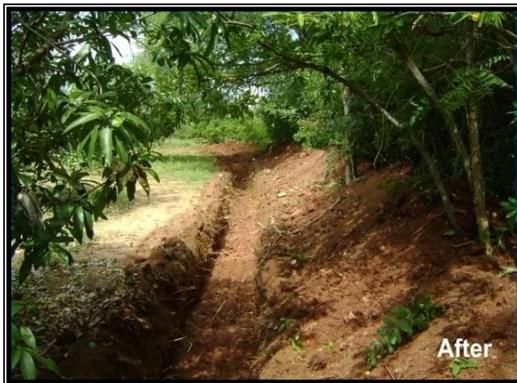
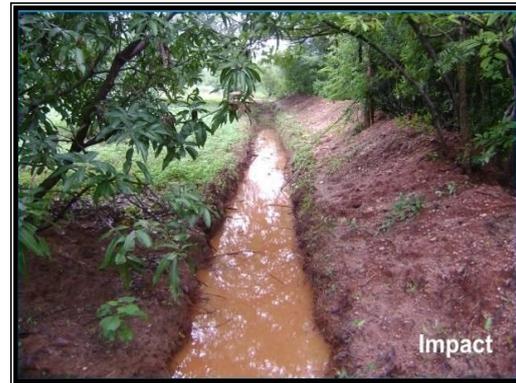
Photo 2 & 3: Pit cum Bunding, Kupilipatti Watershed

The continuous trenches with dimension of 10m x 0.90m x 0.90m were dug with 0.70m gap between the trenches in a line. The earthen bunds were formed in the down stream side of the slope continuously. DWDA gave necessary advice to the village watershed community to motivate the farming community and to level the field in between the trenches. According to the availability of water, the agro forestry seedlings, horticultural plantations were planted.

The pit cum bunding was done in the field as shown in the impact snap. The watershed received 275 mm of rainfall between the 21st – 27th of November 2010. Near the seserve forest boundary where the breath of the land is 400 mts 8 rows of pit chain were formed. Since the intensity of the rainfall is abnormal, the formed pits witnessed efficient water harvesting. It was measured 45cm to 10cm depth of topsoil that was accumulated in the series of rows from the highest elevation in the ridge to the bottom of the field.

The impact was noted in the 11 nos of wells in the downstream portion of the field. Before the depth of water in the bore well was recorded 25 ft during the rainy season and later it got dry during the summer which gave confidence for growing only a single crop. After the intervention in spite of the rainy season the wells had 58ft out of 65 ft depth of standing water level which gave confidence to the farmers to go for the 2nd crop.

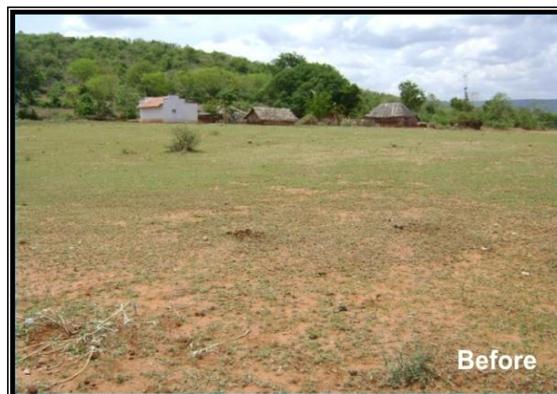
Photo 1: Before project

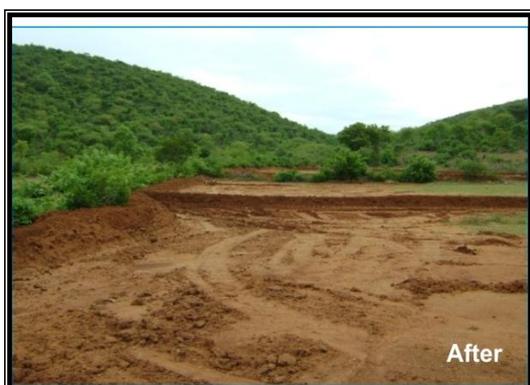
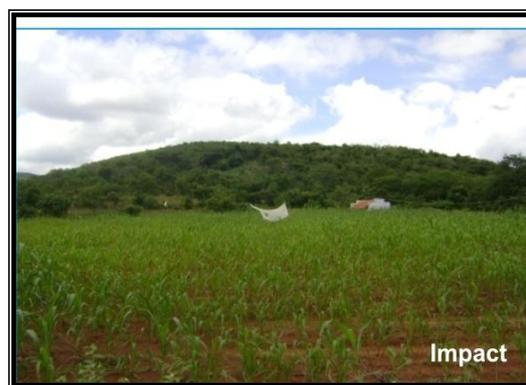
Photo 2 & 3: Land leveling & Earthen Bunding, Palanipatty Watershed

The Watershed comprised of red soil and red loamy soil. It was initially decided to form bunds along the contours in the upper portion of the Watershed. Compartmental bunding was formed in the middle and lower portion with the dimension of top width of 0.45m, bottom width of 1.05m and to the bund height of 0.45m. DWDA gave necessary advice to village Watershed community to perform the bunding from the ridge and to maintain the excess water draining outlets. According to the availability of water, the agro forestry seedlings, horticultural plantations with the suitable intercropping were advised.

The maximum run off was collected within the field which improved the soil texture and soil moisture. The top soil erosion was arrested and restricted within the bunds. The

segregation of their land with bunding gave basic layout for planning during planting and fertigation. They grew grass over the periphery of the bunding which stabilized the cross section.

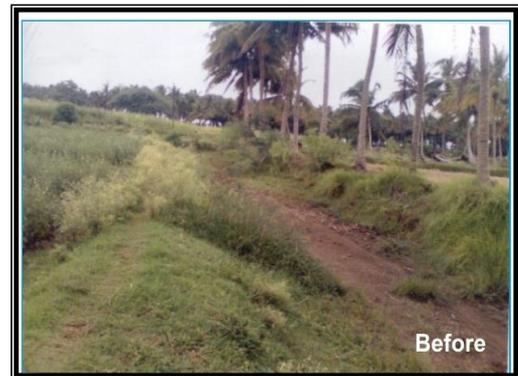
The slope of the land is more than 7% and the lands in this sloppy portion starve for conservation from all types of erosion and loss in the top fertile soil. There was a great need that the stream water had to flow with lesser velocity which could reduce scouring the Agriculture lands in the curves of the stream. A structure was needed to protect the patta land from erosion by stream and erosion from the land.

Photo 1: Before project

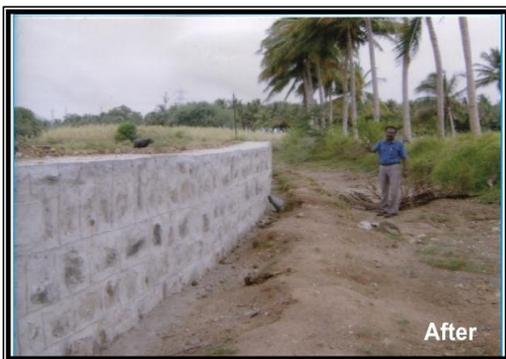
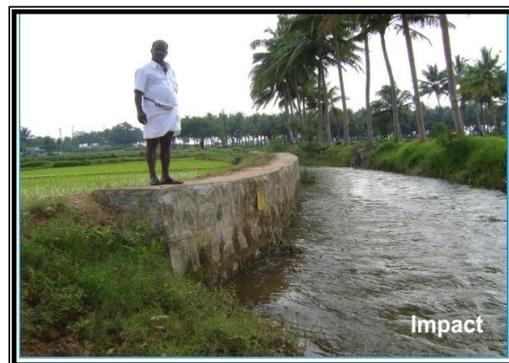
It was planned to construct retaining wall built with random rubble masonry structure in the vulnerable curves between the Agricultural field and the stream. So that the retaining wall could collect the movement of top soil within the field itself in the upper side and protection from the severity of high velocity steam. Since the retaining wall gives boundaries to the particular field, the new area in the tipoff the field which was previously sloppy without agri usage is now made into an agri field.

Photo 2 & 3: Retaining Wall & its impact

It was constructed with the dimension of 0.50m width and height ranging from 0.60m to 1.20m. It was constructed with the random rubble masonry. There were 220 mts of retaining wall constructed in each Watershed.

The construction of retaining wall stabilized the Agriculture from approximately 31 Ha. per Watershed which was affected seriously from the erosion directly and 39 Ha. of land indirectly by submerging during monsoon.
